Real-time drilling process monitoring for soil nailing works for slope upgrading works

N.L. Ho, K.M. Yau, M.J. Wright & K.L. Wong Ove Arup & Partners Hong Kong Ltd, Hong Kong Special Administrative Region, China

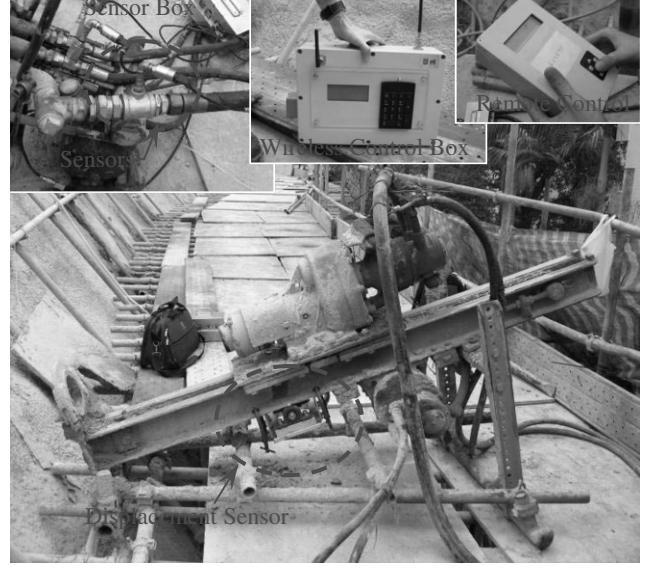
Plate 1. Setup of DPM sensors on a typical rotary percussion drilling rig.

The DPM equipment mainly consists of 1 displacement and 5 pressure sensors. The displacement sensor is mounted onto the drilling rig "mast" and engages the steel loop chain of the drilling rig to record forward and backward movement of the drill string. The pressure sensors measure the required hydraulic pressure for percussion of the down-the-hole hammer, upward and downward thrust on the drilling bit, and clockwise and anti-clockwise rotation of the drill string (Lai & Lo, 2008; ETI, 2006a & 2006b). All of the pressure sensors are mounted onto the control panel of the drilling machine. Calibration for each drilling rig is required to ensure that appropriate parameters are adopted for data processing. A photograph showing the setup of the sensors on a typical rotary-percussion drilling rig is given in Plate 1.

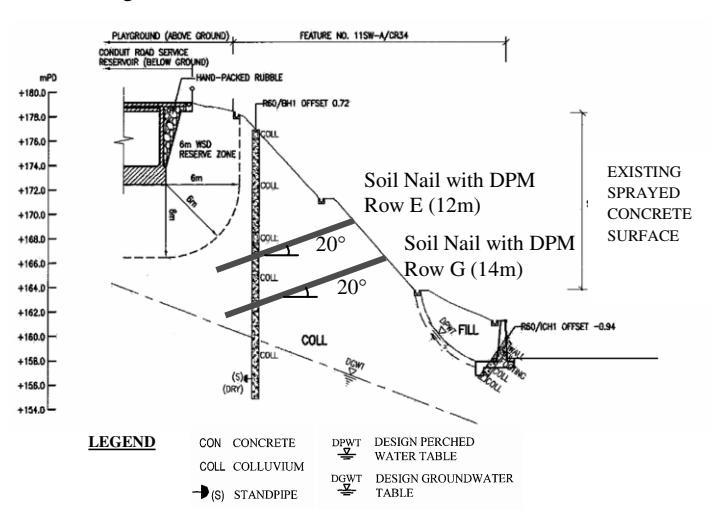
Figure 1. Geological model of Feature No. 11SW-A/CR34.

Two sites were selected to carry out real-time DPM. Feature No. 11SW-A/CR34 is located in Mid-levels on Hong Kong Island. The feature is a 16m high cut slope with a 3m high reinforced concrete retaining wall along the toe. Based on the previous studies, geotechnical investigation, aerial photographs interpretation as well as previous and recent ground investigation (Arup, 2007a), the soil strata of the feature is a succession of Fill and Colluvium. Colluvium mainly comprises firm, yellowish red, sandy, clayey silt with sub-angular to subrounded fine to coarse gravel, cobble and boulder sized rock fragments (Arup, 2007a). Shear strength parameters of c' = 3kPa and $\phi' = 38^{\circ}$ were adopted for Colluvium in the slope stability analysis. The DPM was selected to be carried out within the Colluvium with voids and cavities, and excessive cement grout losses were anticipated to be encountered at some of the drillholes. A simplified geological model of the feature is shown in Figure 1.

The DPM was carried out at 4 numbers of 12m long drillholes (nos. E27 to E29 and E34) and 11 numbers of 14m long drillholes (nos. G24 to G29, G32, G34 and G36 to G38). The diameter of drillholes was 100mm with drillholes inclined at 20° to the horizontal with a 1.5m horizontal spacing. A geological section of the feature is shown in Figure 1.

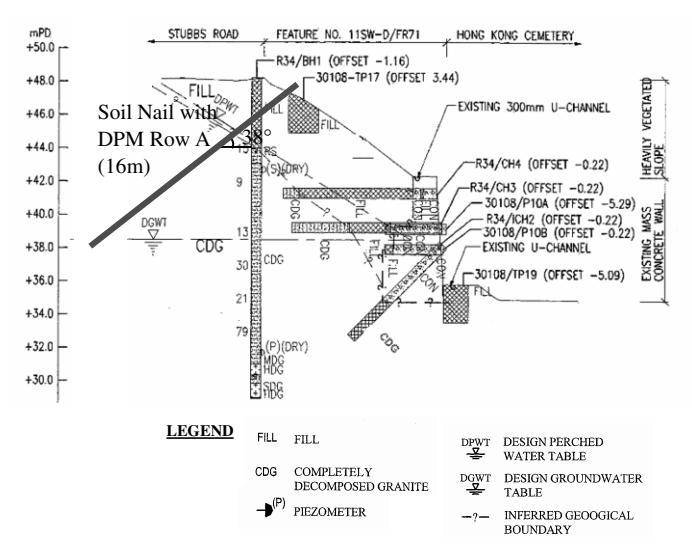
Figure 2. Geological model of Feature No. 11SW-D/FR71.

of up to 8.0m of Fill underlain by Completely Decomposed Granite (CDG). The DPM was carried out within the Fill and CDG. The Fill comprises loose to dense, silty, fine to coarse sand with some angular to sub-angular fine gravel-sized quartz fragments and occasional angular to sub-angular fine to coarse gravel-sized highly decomposed Granite fragments. The CDG comprises extremely weak, moist, completely decomposed medium grained Granite (Arup, 2007b). In-situ relative compaction tests carried out in trial pits within the Fill found results varying between 72.6% and 95.3% of the maximum dry density. SPT-N values of 9 to 79 were obtained within the CDG (GCE, 2007). Shear strength parameters of c' = 0kPa and φ ' were adopted for Fill and c' = 5kPa and φ' = 37 = 33and CDG respectively in the slope stability analysis. The geological model of the feature is shown in Figure 2

The DPM was carried out at 10 numbers of 16m long drillholes (nos. A8 to A11, A14 to A16, and A18 to A20). Diameter of drillholes was 100mm with drillholes inclined at 38° to the horizontal with a 1.5m horizontal spacing. A geological section of the feature is shown in Figure 2.

A significant change in drilling rate from an average of 2.73 m/minute to an average of 2.02 m/minute is observed at the depth of about 4m as shown in Figure 5. This change of drilling rate may indicate a change in soil strength. With reference to the geological section of the slope in Figure 2, the Fill/CDG interface is about 4m below the slope surface at soil nail Row A which coincides with the change in drilling rate measured by the DPM. There was no large variation of drilling rate and excessive grout loss was not encountered at the drillholes at Feature No. 11SW-D/FR71.

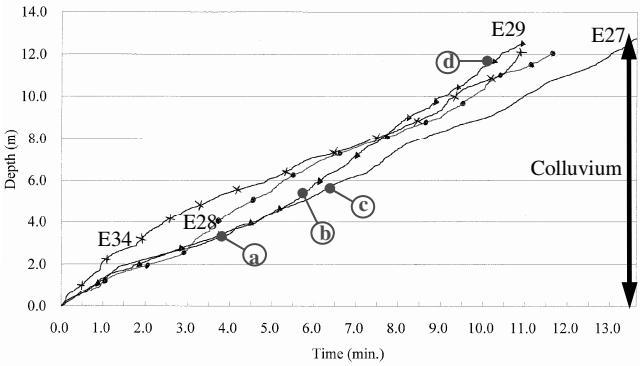
Figure 3. Depth vs Time Graph of DPM Results for Feature No. 11SW-A/CR34 (Soil Nail Row E).

Drilling rate graphs (depth vs time graphs) were downloaded from HKU's designated secure website and retrieved. Average drilling rates ranging from 0.43 m/minute to 2.73 m/minute were obtained from DPM results at the above drillholes. CCTV survey was conducted at drillholes nos. E27 to E29, E34 and G29 to G31. The drilling rate graph for the DPM of 4 drillholes (nos. E27 to E29 and E34) is extracted and illustrated with some photographs recorded during CCTV survey which are shown in Figure 3.

From the drilling rate graph of Rows E and G drillholes of Feature No. 11SW-A/CR34 (Figures 3 and 4), the average drilling rate ranged from 0.43 m/minute to 2.73 m/minute. The relatively fast drilling rate (i.e. 2.73 m/minute) indicates that the drill bit was drilling through relatively soft materials while the slow drilling rate (i.e. 0.43m/minute) indicates that the drill bit was

In Figure 3, the graph gives consistent drilling rate of 1.07 to 1.30 m/minute at first 2m of drillholes nos. E27 to E29. From the depth of 2 to 4m, the drilling rate is about 0.64 to 0.83 m/minute. The relatively slow drilling rate indicates that the ground from 2 to 4m comprises relatively hard materials. From the depth of 4m onwards, the penetration rate become irregular and voids or cavities were probably encountered which are correlated with the CCTV survey. Some photographs of the CCTV survey were captured and shown in Plate 2.

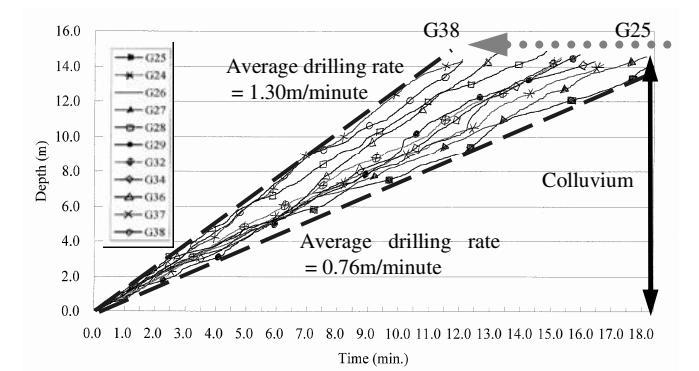
Figure 4. Depth vs Time Graph of DPM Results for Feature No. 11SW-A/CR34 (Row G).

The drilling rate graph for the DPM of the remaining 11 drillholes (nos. G24 to G29, G32, G34, and G36 to G38) is extracted and shown in Figure 4. The overall average drilling rate ranges from 0.76 m/minute to 1.30 m/minute as shown in Figure 4. In general, the drilling rate gradually increased from drillhole nos. G25 to G38, which was probably due to changes of soil strength along the slope. A significant variation of drilling rate is observed from of 9 to 12.5m depth in some drillholes (nos. G24, G25, G26 and G29). Penetration rates ranged from 0.56 m/minute to 5.6 m/minute. This indicates significant changes of ground conditions. High penetration rates of 2.07 m/minute and 5.6 m/minute were observed at the depth of about 10.6 to 12.1m and 9.2 to 9.8m of drillhole nos. G26 and G29, respectively, which indicates the presence of very soft soil and/or cavities. Excessive cement grout loss greater than 10 times of the theoretical volume of the drillhole was encountered at drillhole nos. G24, G26 and G27 and pre-grouting operation was adopted for drillhole nos. G28 and G29 to solve the grout loss problem.

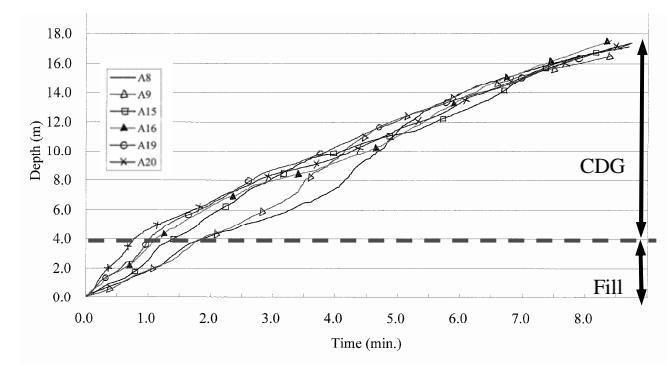
Figure 5. Depth vs Time Graph of DPM Results for Feature No. 11SW-D/FR71 (Row A).

Drilling rates ranging from 1.38 to 4.68 m/minute were obtained for the Fill layer from DPM results at the above drillholes. The depth vs time graph for the DPM of 6 selected drillholes is extracted for illustration and shown in Figure 5.
