Slope stability analysis using conventional methods and FEM Analyse sur la stabilite de la pente en utilisant des methodes conventionelles et FEM

Keywords : slope stability, FEM

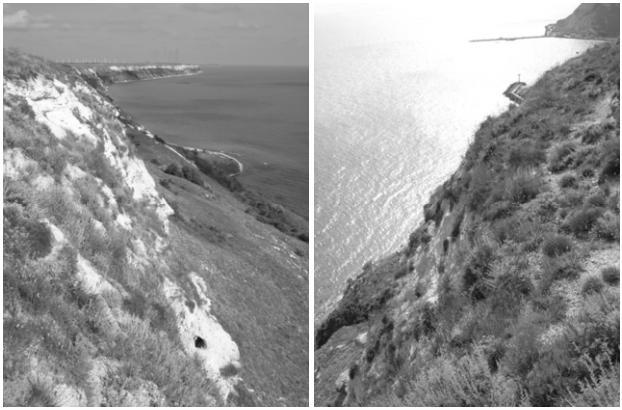
Fig. 1. Slope view and situation

In connection with the construction of a hotel complex on the Black Sea shore in the vicinity of the town of Kavarna, Bulgaria, a numerical investigation was carried out to determine and prove the stability of the site slope (Fig. 1). The main aim was to observe the slope behavior during the construction and in operation so as to determine the safety factor with taking into account the anticipated seismic forces for the area.

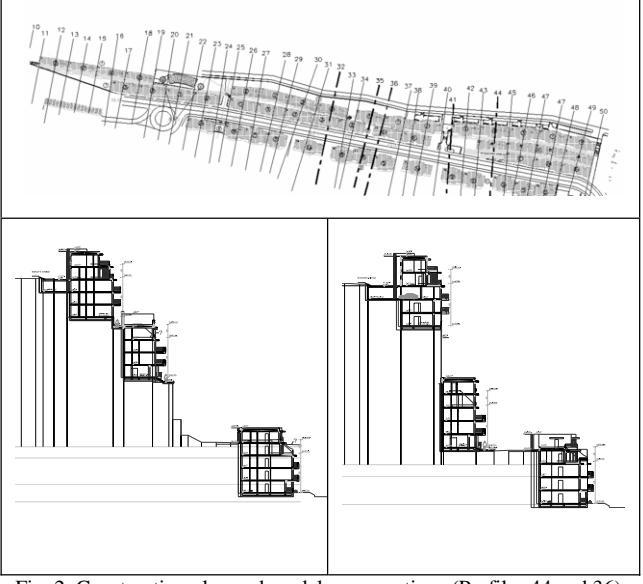
Fig. 2. Construction plan and model cross sections (Profiles 44 and 36).

The slope is designed for construction as shown in the diagram and profile in Fig. 2. According to the Bulgarian regulations for designing structures in earthquake areas, the area concerned has a 9th degree seismic intensity, with a seismic coefficient of K_c =0,27. In compliance with the materials

As can be seen from Fig. 2, calculations are required in different profiles in view of the non-homogeneous terrain relief and various architectural solutions. Of interest regarding the aims set in this paper is the analysis of the slope behavior in one particular profile. For the purpose, one of the most unfavorable profiles was selected – Profile 36 whose cross section is shown in Fig. 2. All subsequent analyses and calculations were carried out for Profile 36. A similar approach was used for solving all other profiles (for example Pr.44 - Fig.2).

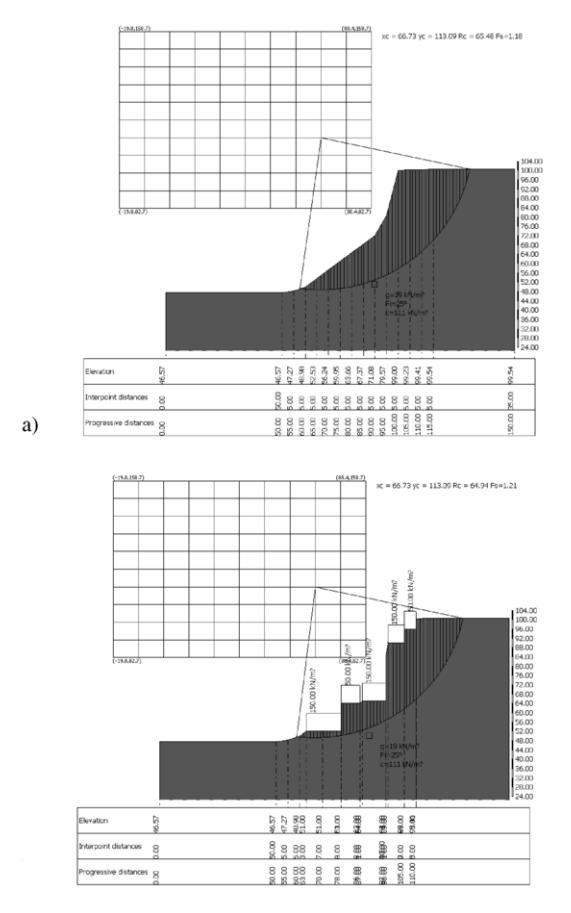
Fig. 3. Results of Geostru Slope 2008 according to Bishop's method: a) Natural slope; b) Operational conditions .

The computations were made by using four versions of the method of slices (Fellenius, Bishop, Janbu and Bell) and the computational schemes are shown in Fig. 3. The results obtained on the minimum safety factor under operational conditions are summarized in Table 2. The results of investigating the total stability without taking into account local losses of stability show clearly that regardless of the method used, the stability coefficient values are close to the normative ones (F_s =1,25 – for basic combination of loads and 1.15– for special combination of loads and calculations made by the Bishop's method.

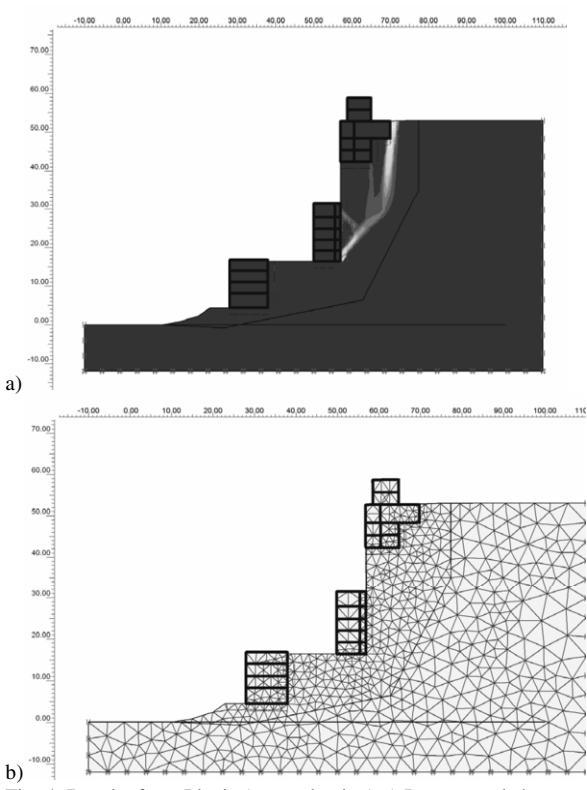
Fig. 4. Results from Plaxis (ϕ ,c–reduction) a) Incremental shear strains; b) finite element network.

Along with the calculations using the method of slices, the slope was modeled in an finite element medium and its stability was determined by the $,,\phi,c$ – reduction" method. The numerical model and the form of slope failure are shown in Fig. 4. The value obtained for the minimum allowable safety factor (Table 2) is more than twice as low as that for the method of slices.

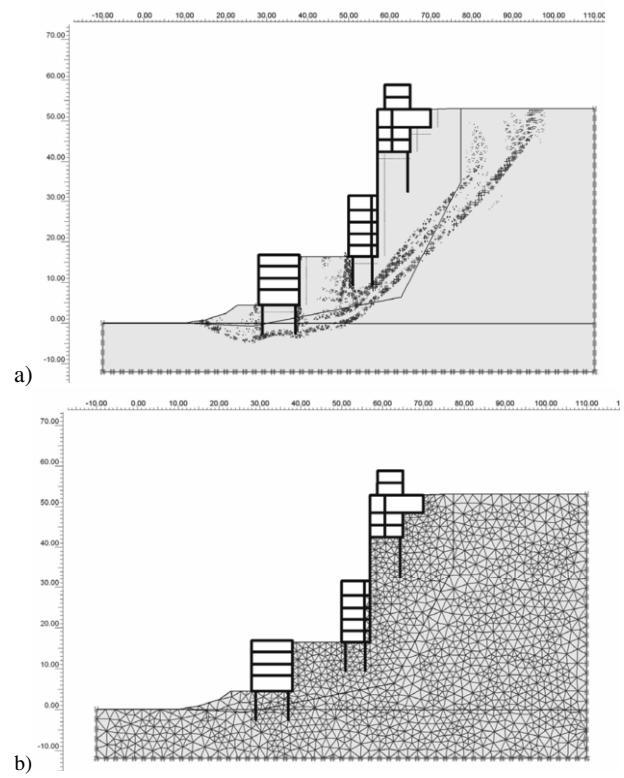
Fig. 5. Results from Plaxis (ϕ ,c – reduction): a) Incremental shear strains ($F_{s(\phi,c-reduction)}=1.368$); b) computational model.

The piles are of two types: cast-in-situ piles, reinforced concrete piles, diameter D=600mm. The pile lengths are 7m and 10m, respectively, for the different buildings (Fig. 5). In plan view they are positioned along the whole length of each building, axially at every 0.70m.

The variant thus obtained served to model and solve the slope by the $,\phi,c$ – reduction" method. The computational scheme and results obtained are shown in Fig. 5. The value of the safety factor sought is $F_{s(\phi,c-reduction)}=1.368$.

The slope failure pattern obtained is close to the assumed form of failure using the method of slices. The safety factor meets the normative requirements.
