# Effect of compaction grouting in loosely packed sand on density

H. Pachen

RandstadRail is the future light-rail link between the cities of Rotterdam, The Hague and Zoetermeer, the Netherlands. In the city area of Rotterdam a shield tunnel will be built for two single track tunnels. The tunnel crosses an intensively used railway track, called the Gouda Link, built on an embankment of saturated loose sand, constrained by very soft clay and peat layers, and reaching almost the Pleistocene sand layer. Boring through and just beneath this loose sand imposes some geotechnical risks, in particular the risk of liquefaction due to monotonic loading. In order to reduce the risks of uncontrolled movements (liquefaction, settlement) during the boring process several design options have been investigated. This paper describes the model test for one of the considered options, densifying the embankment by compaction grouting. The aim of the test was to gain insight in the mechanism and effectiveness of compaction grouting in loosely packed sand. Two effects of compaction grouting are discussed in more detail: i) the change on density and ii) the change on stress level.

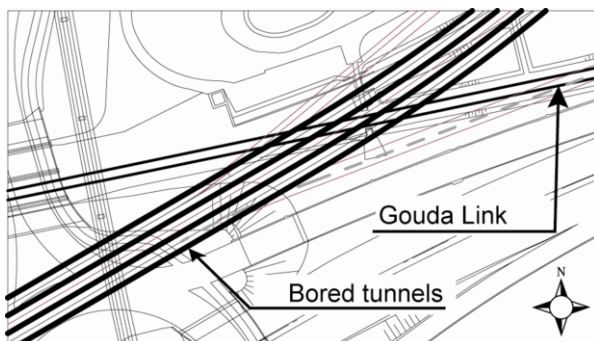
Figure 1: Overview railway crossing Gouda Link

The Gouda Link crossing is a very oblique crossing ( $20^\circ$ ) and therefore quite long (approximately 40 m). See Figure 1 for an overview.

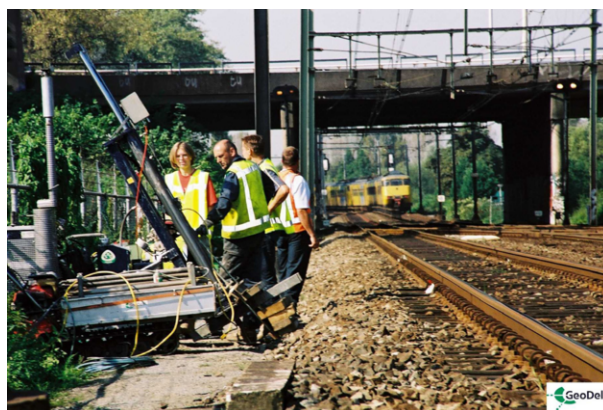
Figure 3: Execution of an inclined CPT.

The anthropogenic sand was investigated from the shoulder of the embankment with inclined Cone Penetration Tests (CPT's, see Figure 3), electric conductivity measurements and borings. The purpose of the electrical conductivity tests was to determine the local density of the sand. In the laboratory classification tests, direct simple shear tests wet critical density tests and special triaxial tests were performed.
